USAAEFA PROJECT NO. 80-07

CLIMATIC LABORATORY SURVEY HUGHES YAH-64 HELICOPTER

FINAL REPORT

MARCH 1982

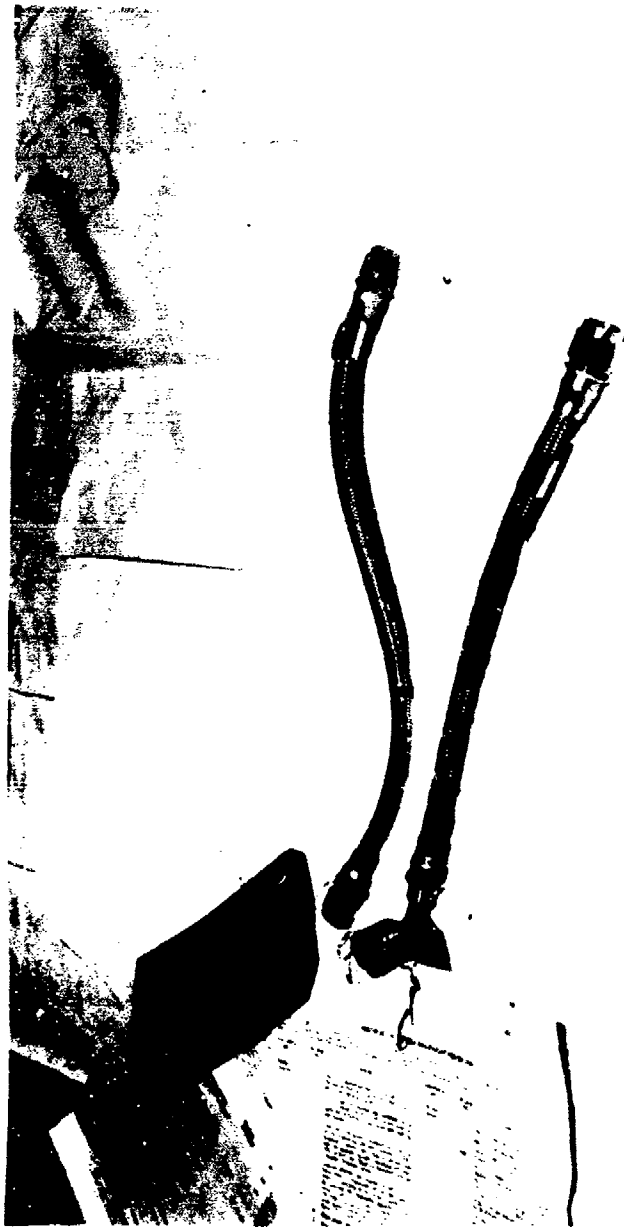
Photo 7. Hydraulic Flex Lines

h. Paragraph 61e. Failure analysis of one failed hydraulic hose indicated that the hose was manufactured with a tube compound that is more susceptible to stress cracking than compounds now in use. The other two hoses could not be located for failure analysis. Production hoses will be manufactured with a more stress crack resistant tube.

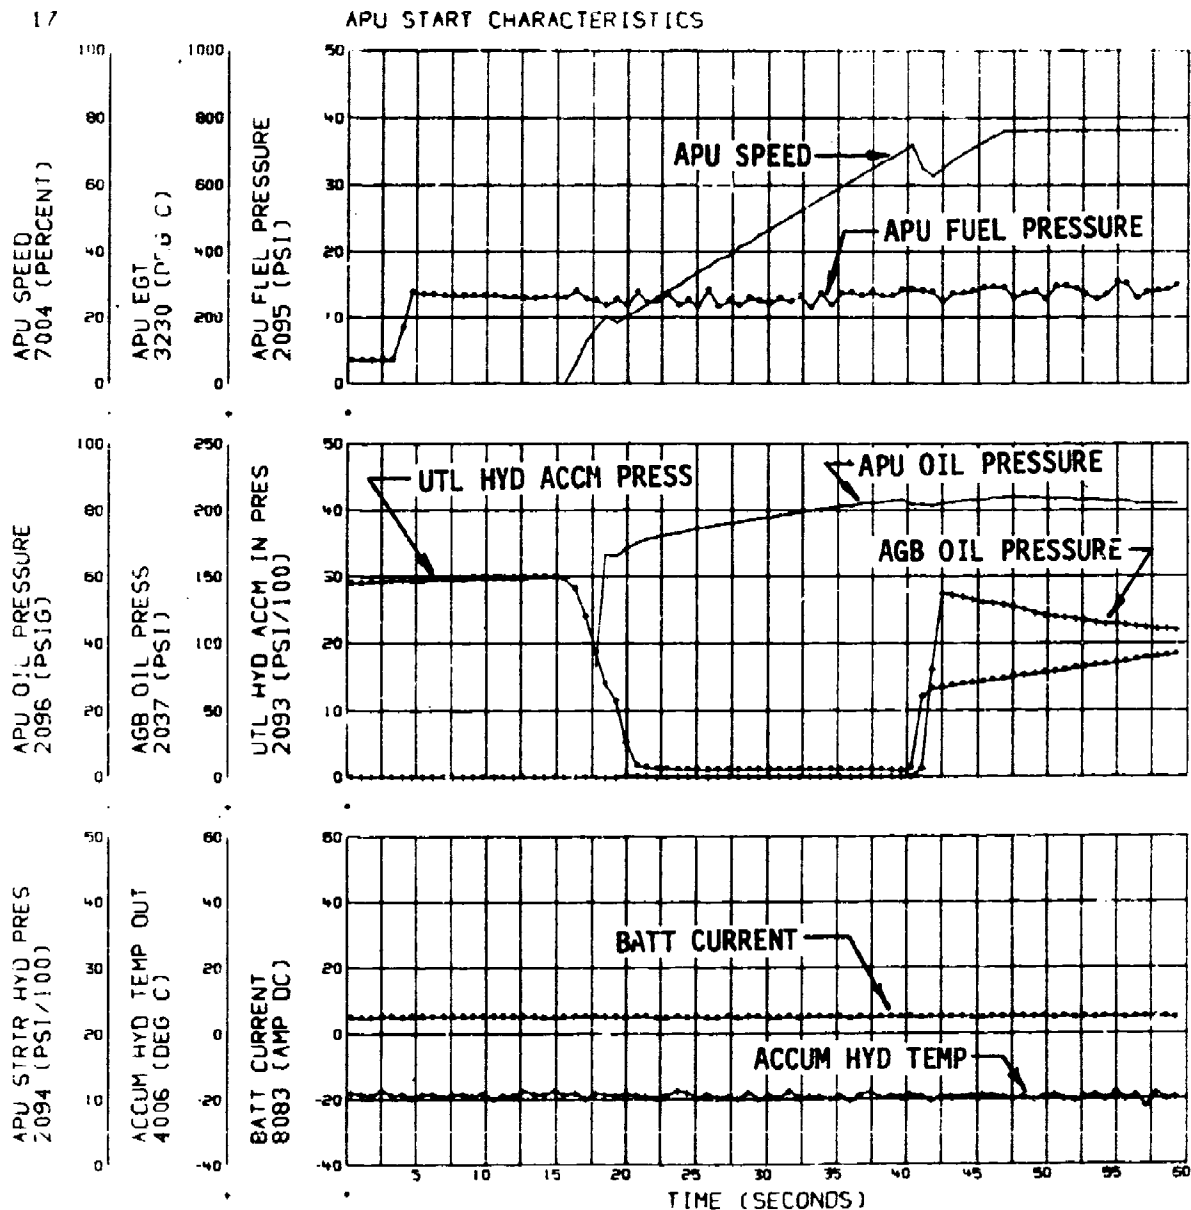
FIGURE 5
APU START CHARACTERISTICS
 APU S/N P113
 YAH-64 USA S/N 74-22249
 CLIMATIC LABORATORY TEMPERATURE -50°F

8. On the first start attempt at -50°F the APU-to-AGB clutch failed (fig 5, app E). The APU achieved operating speed, but could not turn the accessory gearbox. A new clutch was installed and several more start attempts were made. The APU started on each attempt and accelerated to clutch engagement (approximately 60 percent speed). When the clutch engaged, the APU speed decreased to zero and the start sequence was aborted by the APU control unit (fig 6, App E). No problems were encountered at the subsequent 70°F nor $+125^{\circ}\text{F}$ test conditions.

1. APU SERVICED WITH MIL-L-7808H OIL
2. HYDRAULIC SYSTEM SERVICED WITH MIL-H-5606H FLUID
3. JP-4 FUEL UTILIZED
4. ACCESSORY GEARBOX CLUTCH ENGAGED, THEN FAILED
5. APU STARTER HYDRAULIC PRESSURE INSTRUMENTATION UNRELIABLE
6. BATTERY CURRENT INSTRUMENTATION FAILED

d. Paragraph 61a. Failure of the APU to accelerate the accessory gearbox at -25°F and -50°F is a deficiency and fails to comply with the requirements of Paragraph 3.7.5.8.1 of the System Specification. The preceding deficiency is a specification noncompliance because the specification requires that the engine starting system be capable of starting both engines at -25°F without a winterization kit and at -65°F with a winterization kit. This specification noncompliance should be included under Paragraph 63 of the USAAEFA test report. An improved clutch engagement switch is expected to eliminate this problem in production.

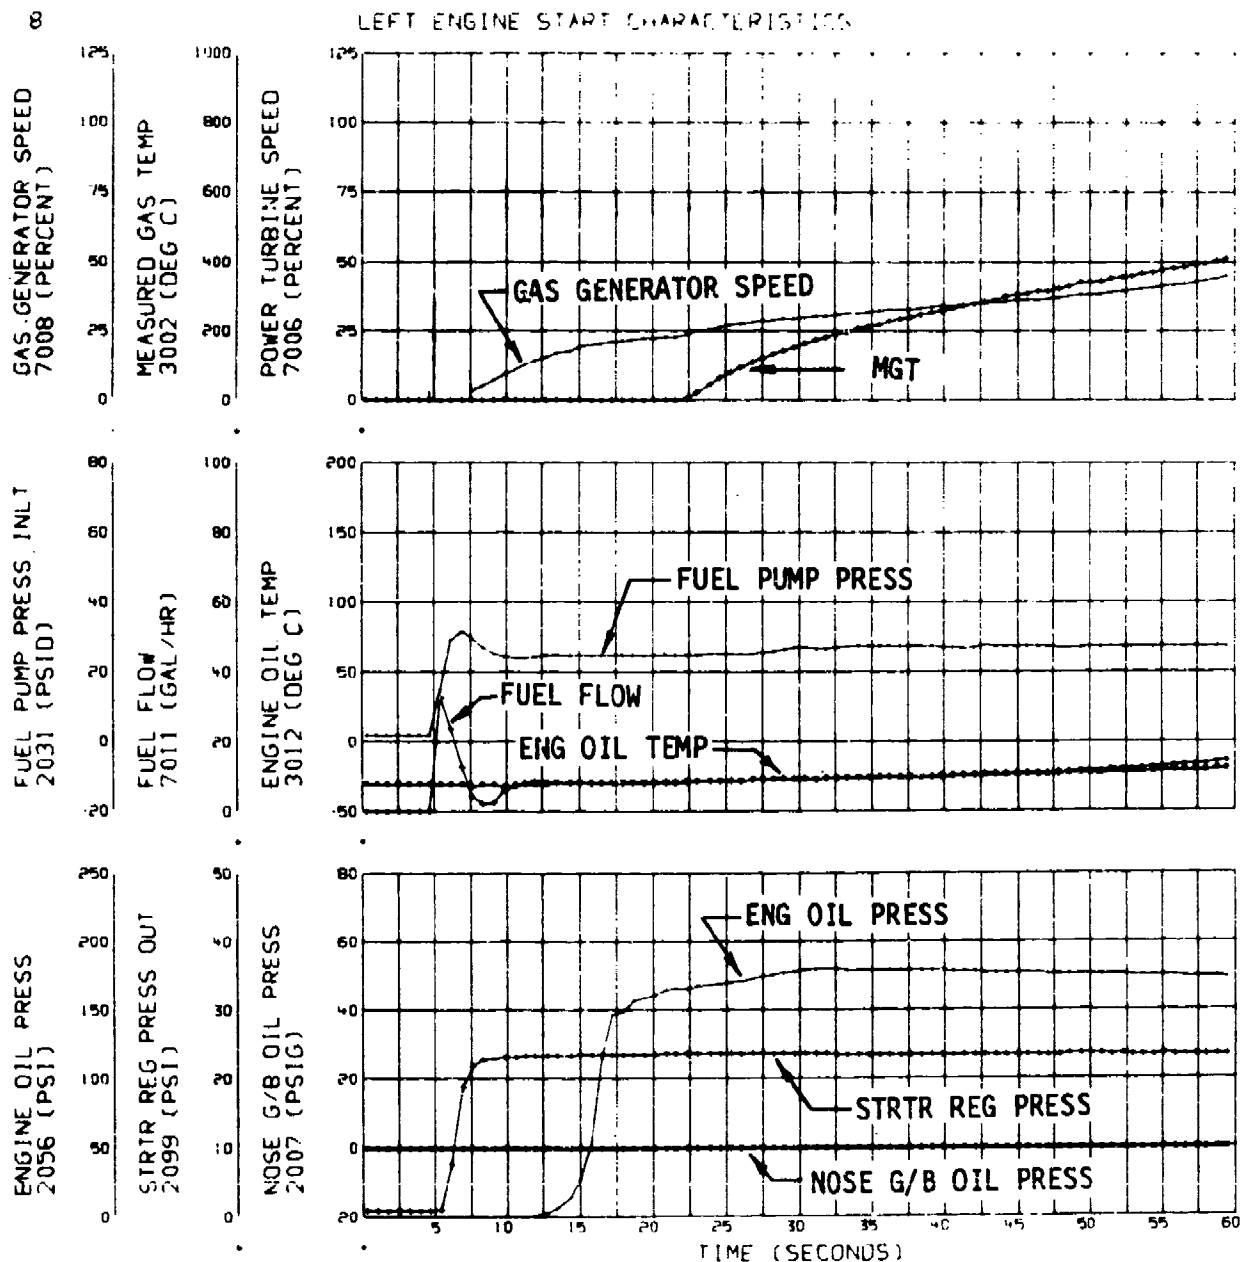
FIGURE 17
NO 1 ENGINE START CHARACTERISTICS
 T700-GE-700R ENGINE S/N 207-263R
 YAH-64 USA S/N 74-22249
 CLIMATIC LABORATORY TEMPERATURE -50°F

14. At -50°F the first several left engine start attempts were unsuccessful (fig 17 app E). The cold weather start procedure which requires cycling the ECL was used during these attempts. Fuel flow to the engine during these attempts was 3 to 4 gallons per hour. Fuel flow during successful starts was 9 to 12 gallons per hour. The engine hydromechanical unit was replaced and subsequent starts were successful.

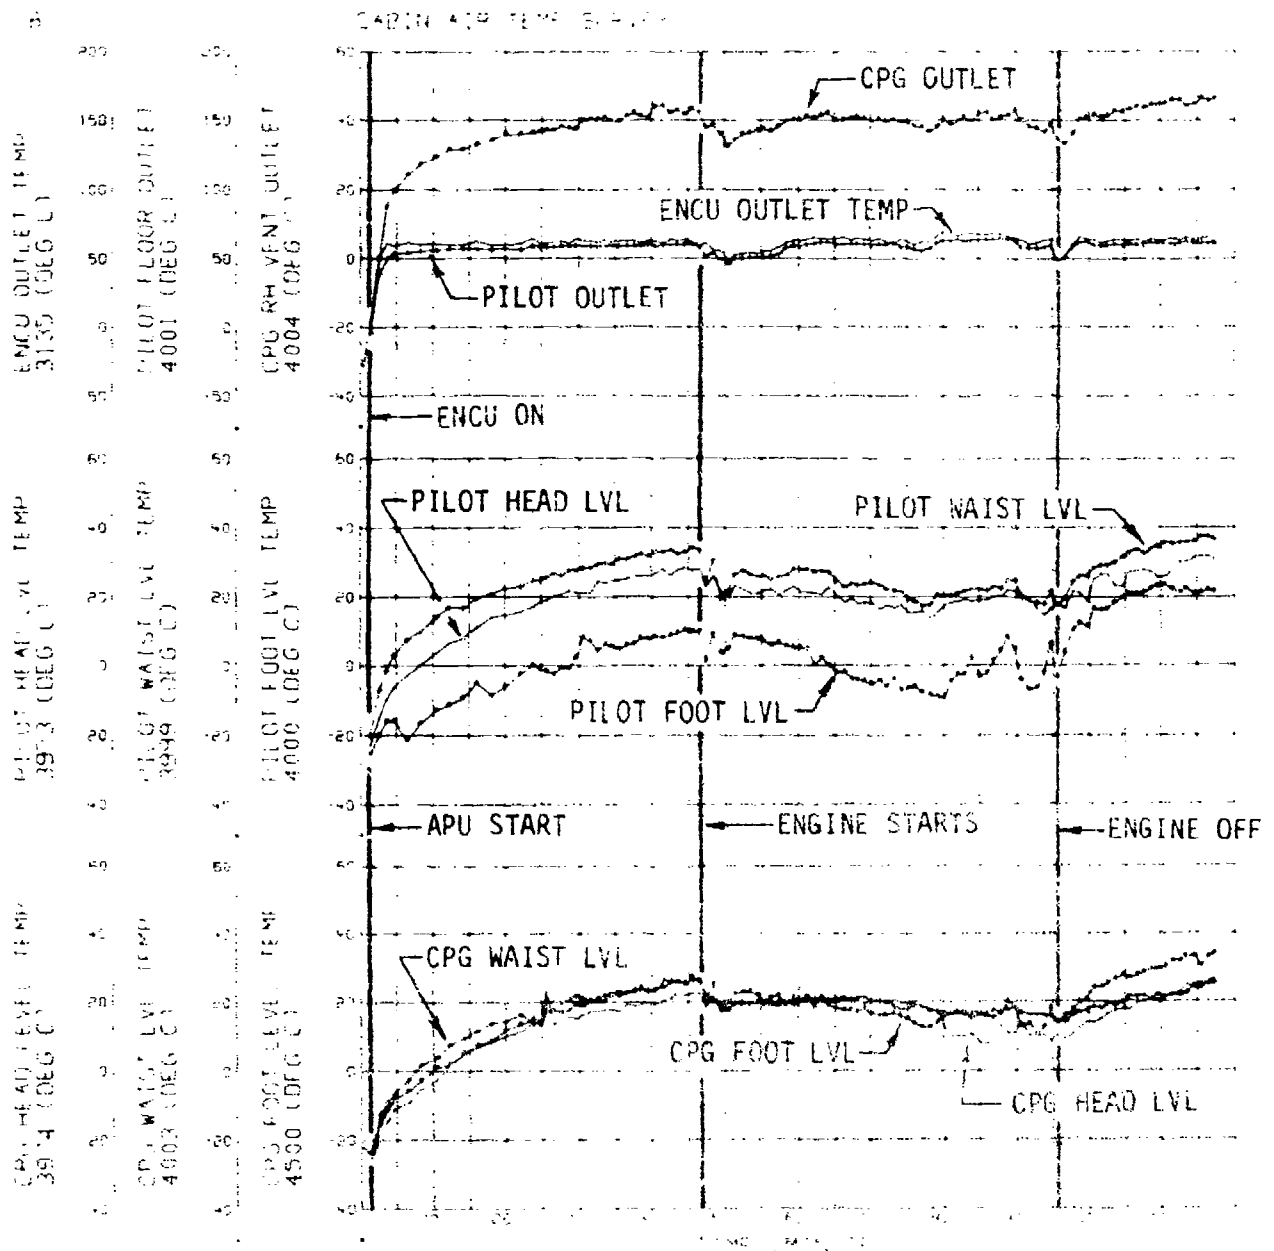
FIGURE 39
CABIN AIR TEMPERATURE SURVEY
YAH-64 USA S/N 74-22249
CLIMATIC LABORATORY TEMPERATURE -25°F

21. The heating operation of the ECS was tested at -25°F (-32°C) and data are presented in figures 39 and 43, appendix E. The ENCU outlet temperature averaged 149°F (65°C) during the test with insignificant duct losses between the ENCU and the pilot station. Between the pilot and CPG outlet, however, the conditioned air temperature dropped by 45°F (25°C). The time to reach the required minimum temperature of 40°F (4°C) at the pilot station was 4 minutes at the waist, 8 minutes at the head, and 28 minutes at the feet. The temperature at the pilot's feet was below freezing for nearly half of the 2 hour mission. The pilot's feet and hands were very uncomfortable during this test. The temperature at the

cyclic grip was 32°F (0°C) as measured with hand-held instrumentation. The waist-level temperature presented in figure 39 (which averaged approximately 70°F) was measured near the left edge of the pilot's seat and had ECS air blowing directly on the sensor. The difference between the pilot head and foot level temperatures averaged 14°F (8°C) and was a maximum of 22°F (12°C). This large temperature gradient was caused mainly by cold ambient air entering the cockpit through the 30 mm weapon turret and holes in the floor around the pedals. Table 3 presents speeds of air blowing up through the holes in the floor as measured with hand-held instrumentation in the aft cockpit. At high power settings, the air speeds increased and produced wind chill effects which added to crew discomfort. The pilot's lower duct outlets being closed also contributed to the temperature difference. The temperatures at the CPG station and at the TAD/PNVS and FABS inlets reached the minimum temperature of 40°F (4°C) in 10 minutes. Temperatures in the CPG cockpit were acceptably uniform during the test.

24. The ECS failed to provide adequately conditioned air to the cockpits or avionics except at 70°F. At -25°F the ECS failed to keep the pilot's feet and hands above freezing during simulated flight profiles. During tests conducted at -50°F the cockpit and TADS/FABS temperatures were below freezing up to one hour after start of the ENCU. The cooling capacity of the ECS was limited at 125°F, lowering the cockpit and TADS temperatures a maximum of 35°F from ambient conditions. Many electronic components of the mission equipment failed due to high temperature during this test (see Appendix H). Crew fatigue in a high work load environment will occur within the first few minutes at extreme temperatures without properly conditioned air in the cockpit. The failure of the ECS to provide adequately conditioned air to the crew stations and avionics bays at -25°F, -50°F and 125°F is a deficiency.

e. Paragraph 61b. Failure of the environmental control unit to provide adequate heating and cooling to the cockpits and avionics bays at -25°F , -50°F and $+125^{\circ}\text{F}$ is a specification noncompliance item. Paragraphs 3.7.15.5.1, 3.7.15.5.2, and 3.7.15.5.3 of the System Specification define the requirements for heating, cockpit cooling, and electronic avionics cooling. Paragraph 3.7.15.5.1 requires crew station temperatures of not less than $+40^{\circ}\text{F}$ for outside ambient temperatures down to -65°F . During testing at -25°F temperatures at the pilot's head and foot level were below freezing, and in the case of the CPG did not exceed 32°F one hour after start of testing. Paragraph 3.7.15.5.2 of the System Specification requires that cockpit temperatures do not exceed 85°F for the case of 120°F ambient temperatures. Cockpit temperatures as high as 104°F were measured during testing. Paragraph 3.7.15.5.3 of the System Specification requires that cooling air delivery temperatures not exceed 85°F . Delivery temperatures as high as 100°F were measured during testing. Design changes to the environmental control system are expected to eliminate these problems in production.
